## Test Results

# SCN400 Fender Durability Test

Durability test on a marine fender (Part no. SCN400) comprising of 15,000 cycles of 50% compression and 30% shear.

Trelleborg SCN400 Marine Fender

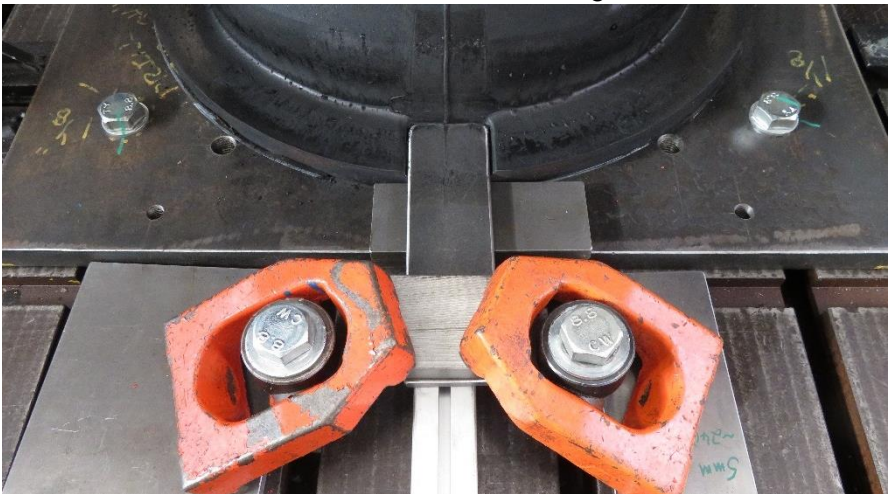
For this test the front bolt on the fender was removed and replaced with a small assembly to clamp the front of the fender to the lower plate. This can be seen in photo 3.

Photo 3- Clamp to replace the bolt

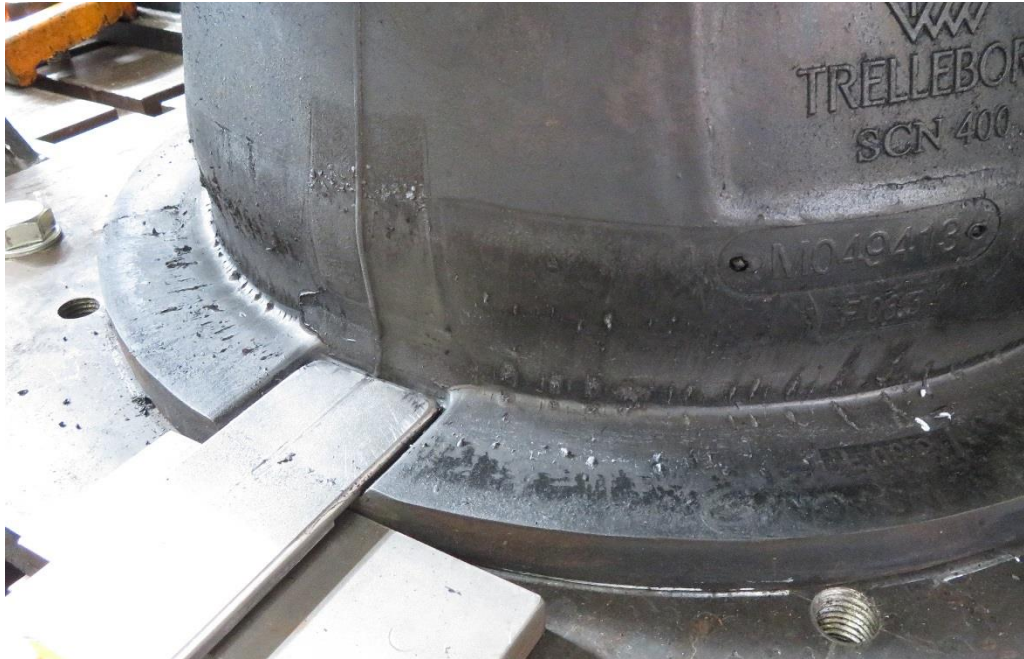
Photo 8- Small rubber deposits seen on the flange

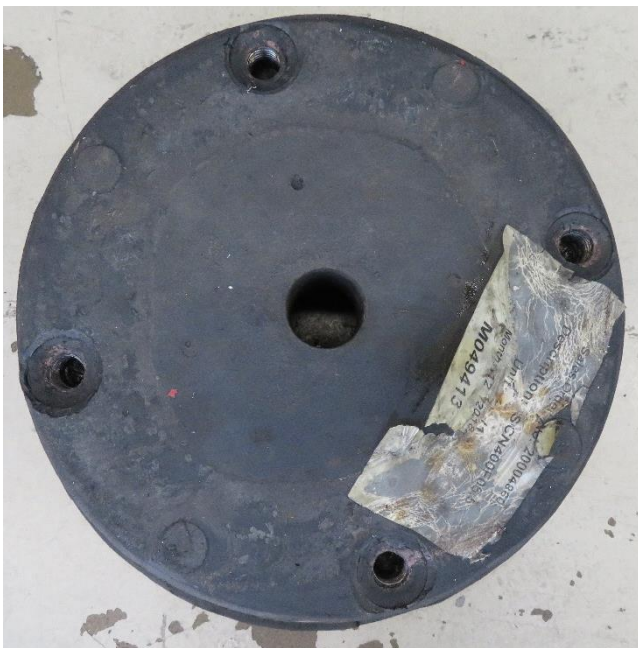
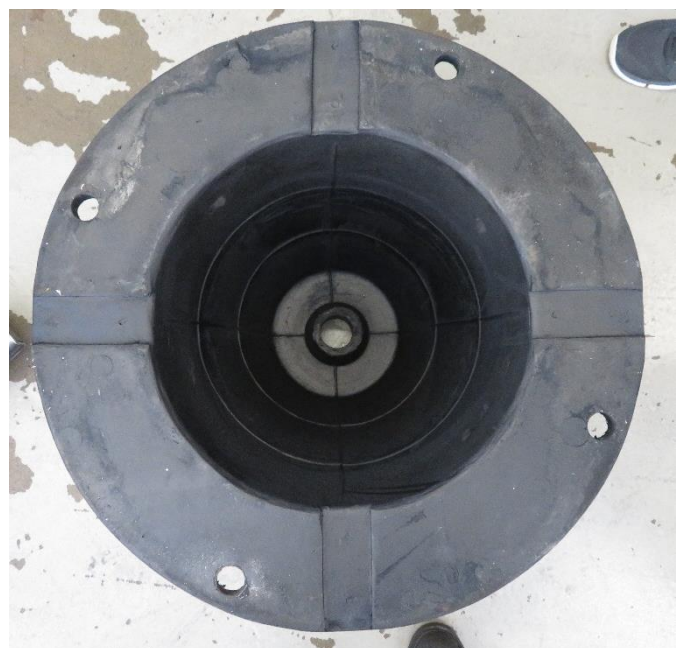
Photo 9 & 10- No cracks seen on upper or lower surfaces

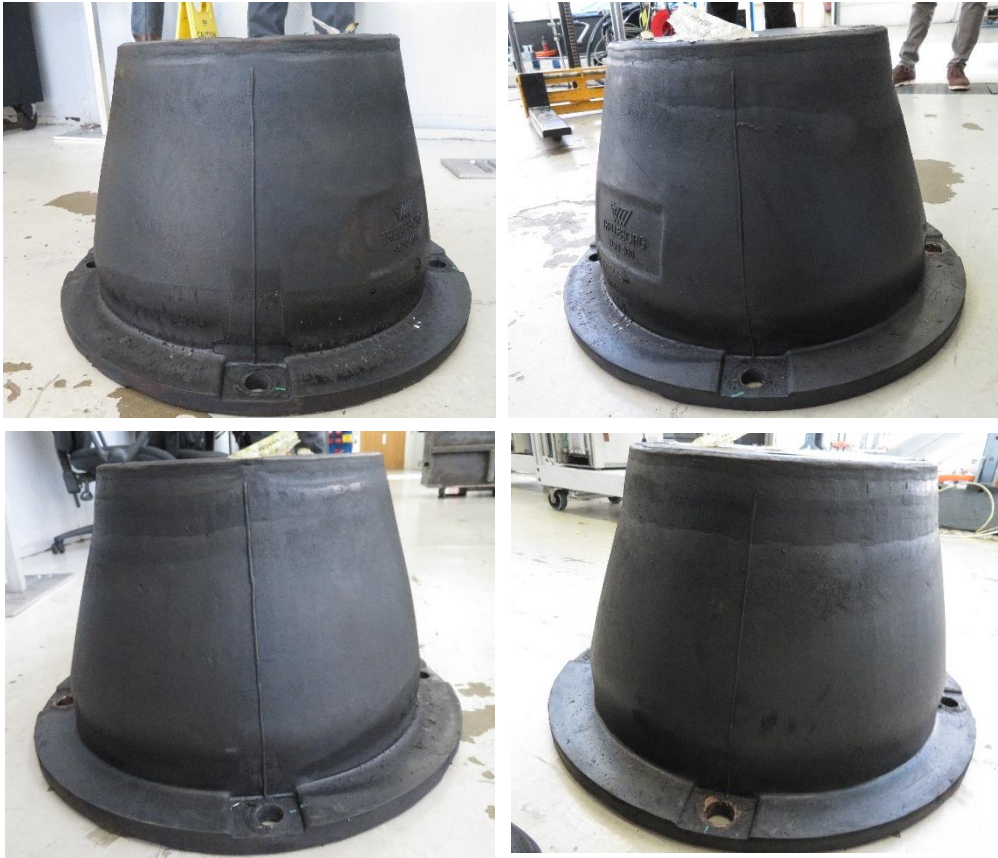
External Visual Inspection

Upon completion of the 15,000 cycles, the test specimen was visually inspected for cracks by MIRA & Trelleborg staff. No damage was found on the external surface. Internally there was a minor crease, seen in internal visual inspection images, which the customer deemed acceptable.
